DEPARTMENT OF TRANSPORTATION**DIVISION OF ENGINEERING SERVICES**

Contract #: 04-0120F4Cty: SF/ALA Rte: 80 PM: 13.2/13.9File #: 82.28**WELDING INSPECTION REPORT****Resident Engineer:**Siegenthaler, Peter**Address:** 333 Burma Road**City:** Oakland, CA 94607**Report No:** WIR-019232**Date Inspected:** 04-Jan-2011**Project Name:** SAS Superstructure**OSM Arrival Time:** 700**Prime Contractor:** American Bridge/Fluor Enterprises, a JV**OSM Departure Time:** 1530**Contractor:** Westmont Industries**Location:** Santa Fe Springs, CA.**CWI Name:** Ruben Dominguez**CWI Present:** Yes No**Inspected CWI report:** Yes No N/A**Rod Oven in Use:** Yes No N/A**Electrode to specification:** Yes No N/A**Weld Procedures Followed:** Yes No N/A**Qualified Welders:** Yes No N/A**Verified Joint Fit-up:** Yes No N/A**Approved Drawings:** Yes No N/A**Approved WPS:** Yes No N/A**Delayed / Cancelled:** Yes No N/A**Bridge No:** 34-0006**Component:** Travelers**Summary of Items Observed:**

SAS-EB Traveler**Fixed Stairs Section**

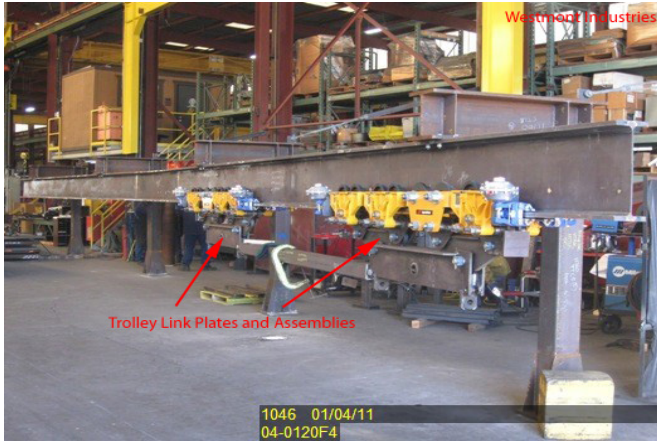
On this date, the QA Inspector observed WMI production welders, Mr. Jose Rodriguez (WID # 3031) and Mr. Eutimo Lopez (WID # 3035) performing Flux Core Arc Welding (FCAW) activities on the Trolley link plates and assemblies. The QA Inspector observed that the welds appeared to be designated as fillet and that Mr. Rodriguez and Mr. Lopez appeared to be performing the FCAW in all positions, throughout the shift.

See attached picture below.
